# Case Studies

Eight case studies demonstrate how substantially damaged houses were elevated in Miami-Dade County After Hurricane Andrew.

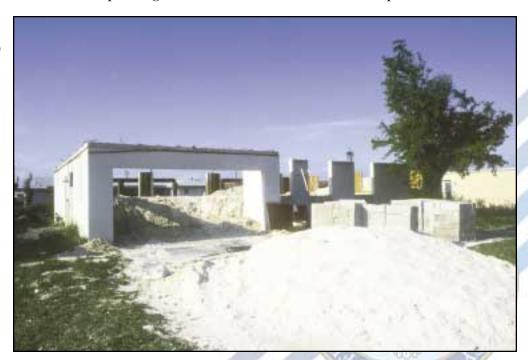
#### Figure 22

The front of the house at the beginning of the project. The interior walls and contents. which were destroyed or severely damaged by flood waters, wind, and rain, have been removed. Sand has been placed on top of the old slab to provide the base for the elevated lowest floor. The concrete blocks that will be used to extend the walls can be seen stored in the foreground.

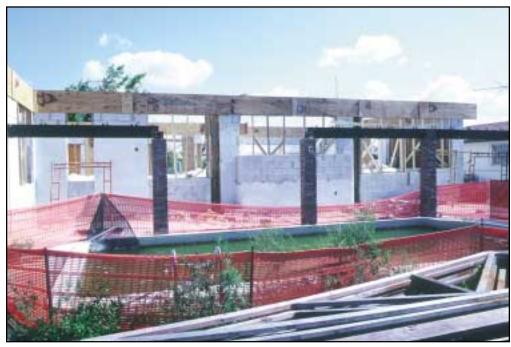
Figure 23

View from the back of the house. The walls have been extended upward with concrete blocks. The plywood visible at the tops of the walls is used to form cast-in-place concrete bond beams that will strengthen the extended walls. The roof trusses shown in the foreground were salvaged for reinstallation. The owner of this house decided to replace the original roof sheathing and shingles with new materials.

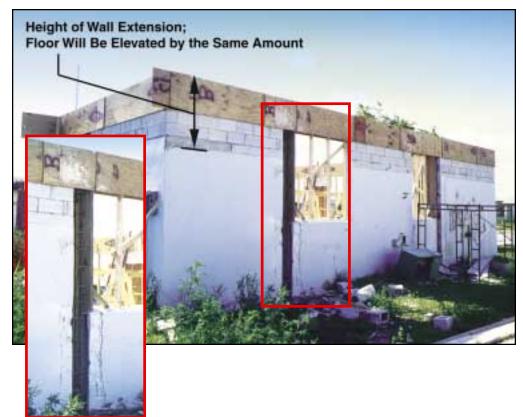
Figure 24

Another view of the extended walls. The vertical cuts in the walls next to the windows are for concrete tiedown columns that will be cast in place to further strengthen the extended walls against wind loads. The owner of this house was able to meet the elevation requirement by raising the floor only a few feet, as indicated by the amount that the walls have been extended.

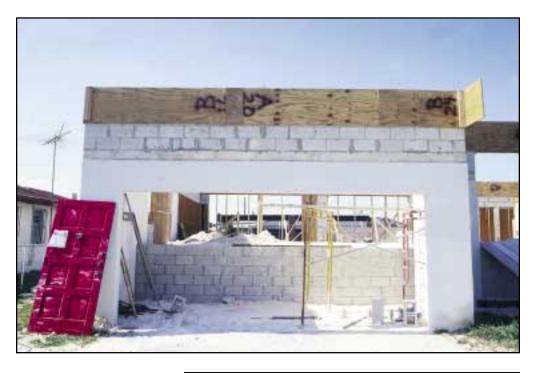
This view through the garage door reveals the different levels of the elevated slab floor, in the background, and the unelevated garage floor.

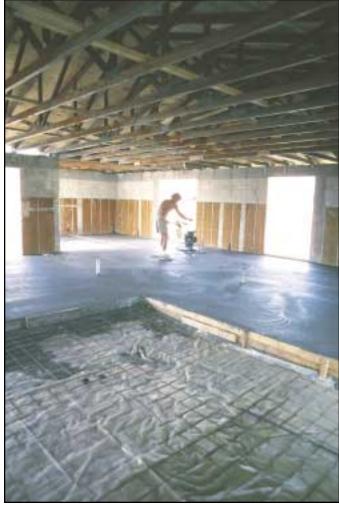
## Figure 26

The roof has been rebuilt with the salvaged trusses, and most of the new concrete slab has been poured on top of the sand fill. The open area in the foreground, where plastic sheeting and wire reinforcement can be seen on top of the sand fill, is where the remaining part of the slab will be poured.

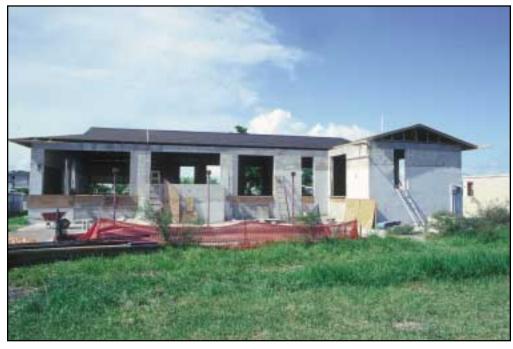
Figure 28
The bottoms of the original window openings are raised with concrete blocks.

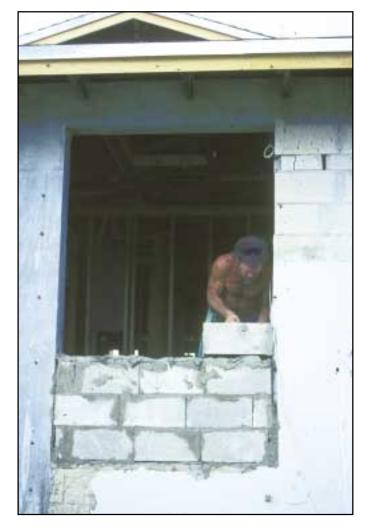
Figure 29 Windows and doors are added. The height

of the raised front door shows the amount of elevation.

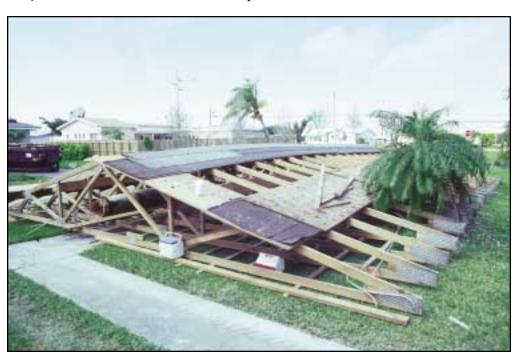
Figure 39
The roof of this house was removed as a single piece; the trusses were held together with bracing and portions of the original roof sheathing. This approach made it easier to reinstall the roof at the end of the project.

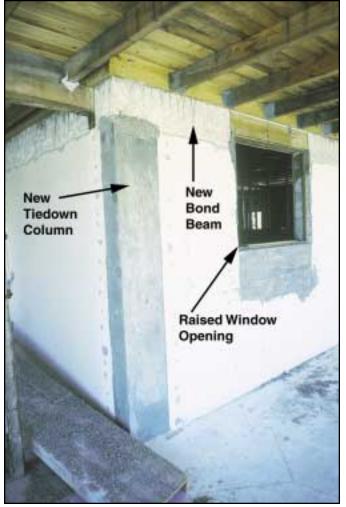
Figure 41

Note the new bond beam at the top of the extended wall, the new concrete tiedown column at the corner, and the raised window opening.

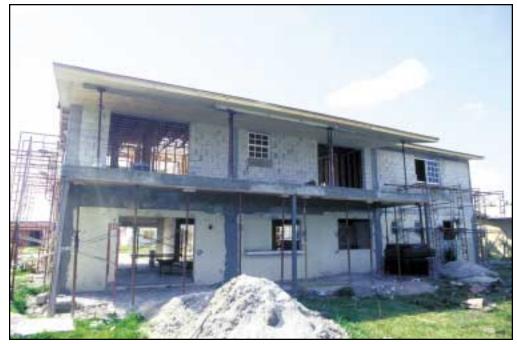
Figure 47

The tiedown columns extend down from the new second-story walls and into the original first-floor walls. The columns tie the first and second stories together and provide a continuous load path that helps the house resist the forces of high winds.

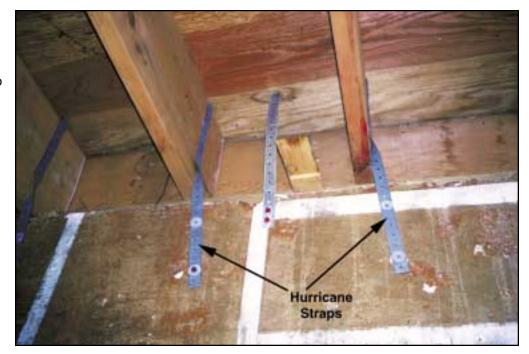
## Figure 63

The new secondstory walls are securely connected to the original first-floor walls with galvanized metal hurricane straps.

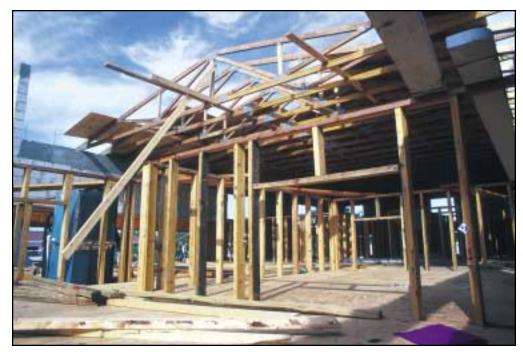
Figure 70
Metal hurricane straps are used to tie the structural members together and create a continuous load path from the roof to the foundation.

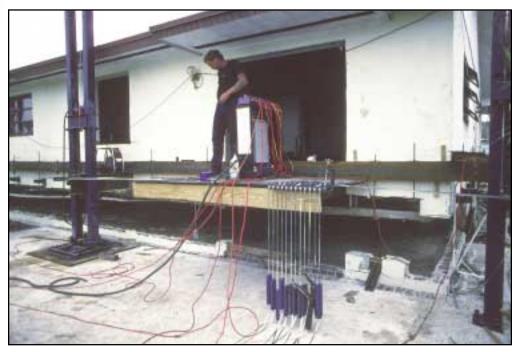
Figure 80

Lifting the house, while simple in theory, is complicated by the need to ensure an equal amount of lift at each jack throughout the process. Too much or too little lift at even one jack can cause the slab and walls to crack. The elevation contractor for this project used a sophisticated jacking system that provided the required level of control.
